DEPARTMENT OF TRANSPORTATION**DIVISION OF ENGINEERING SERVICES**

Quality Assurance and Source Inspection

Contract #: 04-0120F4Cty: SF/ALA Rte: 80 PM: 13.2/13.9File #: 69.15**SOURCE INSPECTION REPORT****Resident Engineer:**Pursell, Gary**Address:** 333 Burma Road**City:** Oakland, CA 94607**Report No:** SIR-001855**Date Inspected:** 19-Feb-2010**Project Name:** SAS Superstructure**OSM Arrival Time:** 700**Prime Contractor:** American Bridge/Fluor Enterprises, a JV**OSM Departure Time:** 1900**Contractor:** Zhenhua Port Machinery Company, Ltd (ZPMC), Changxing Island**Location:** Chang xing dao,Shanghai**Quality Control Contact:** Mr. Don walton**Quality Control Present:** Yes No**Material transfer:** Yes No N/A**Sampled Items:** Yes No N/A**Stock Transfer:** Yes No N/A**OK to Cut:** Yes No N/A**Rebar Test Witness:** Yes No N/A**Delayed/Cancelled:** Yes No N/A**Other:** Coating Inspection**Bridge No:** 34-0006**Component:** See below**Bid Item:** 77,78,79**Lot No:** B #204**Summary of Items Observed:**

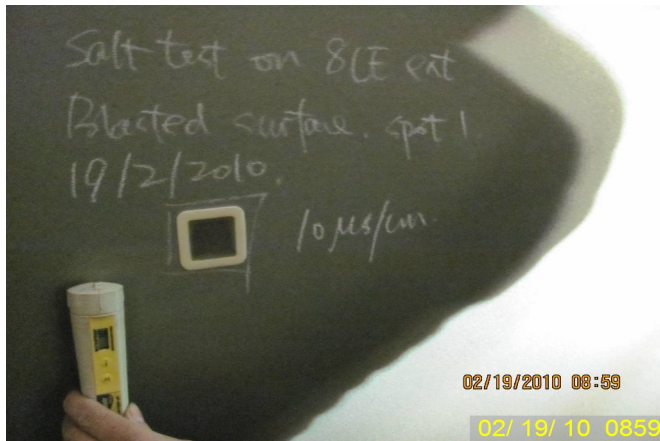
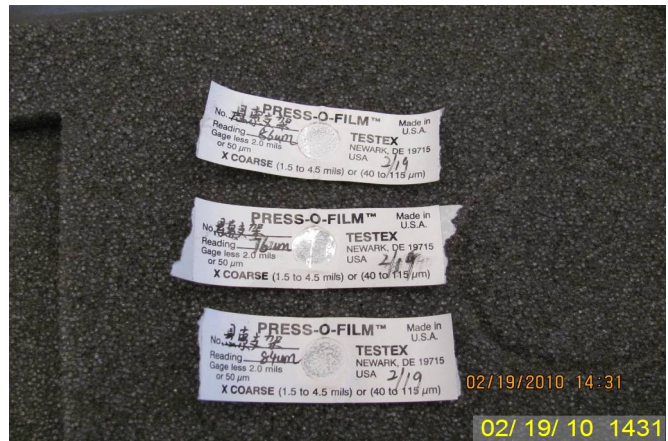
and grinding touch ups on some areas which was marked. Residual chlorides test was conducted by ZPMC on suspender bracket no. SB34E and the result found to be 30 us/cm which is acceptable as per contract documents. Porosity found in 4 places (SB 32E-2 nos, SB32W- 1 no., SB34W- 1 no.) which was marked off for further weld repairs. The ambient conditions found to be 14.7 deg. above dew point and the relative humidity found to be 29. 9% inside the paint shop which is found to be within the parameters of contract documents. After attending the reblasting and grinding touch ups in marked areas It was found that ZPMC submitted notification for the Interzinc 22 application vide request no. 2708 for all 6 sets of suspender brackets. ABF Inspectors inspected all the surfaces and the profile by coarse grain method found to be 76 to 86 microns (Photo attached) which is acceptable as per contract documents.
